EXISTING WINGWALL #2

PROJECT NAME: MONTGOMERY	PLOT DATE: 11-DEC-2013
PROJECT NUMBER: BHO 1448(27)	DRAWN BY: DZENAN K.
FILE NAME: s96j306sub.dgn	CHECKED BY: J. LACROIX
PROJECT LEADER: C. CARLSON	SHEET 18 OF 30
DESIGNED BY: H. SALLS	
EXISTING WINGWALL #2 REPAIR

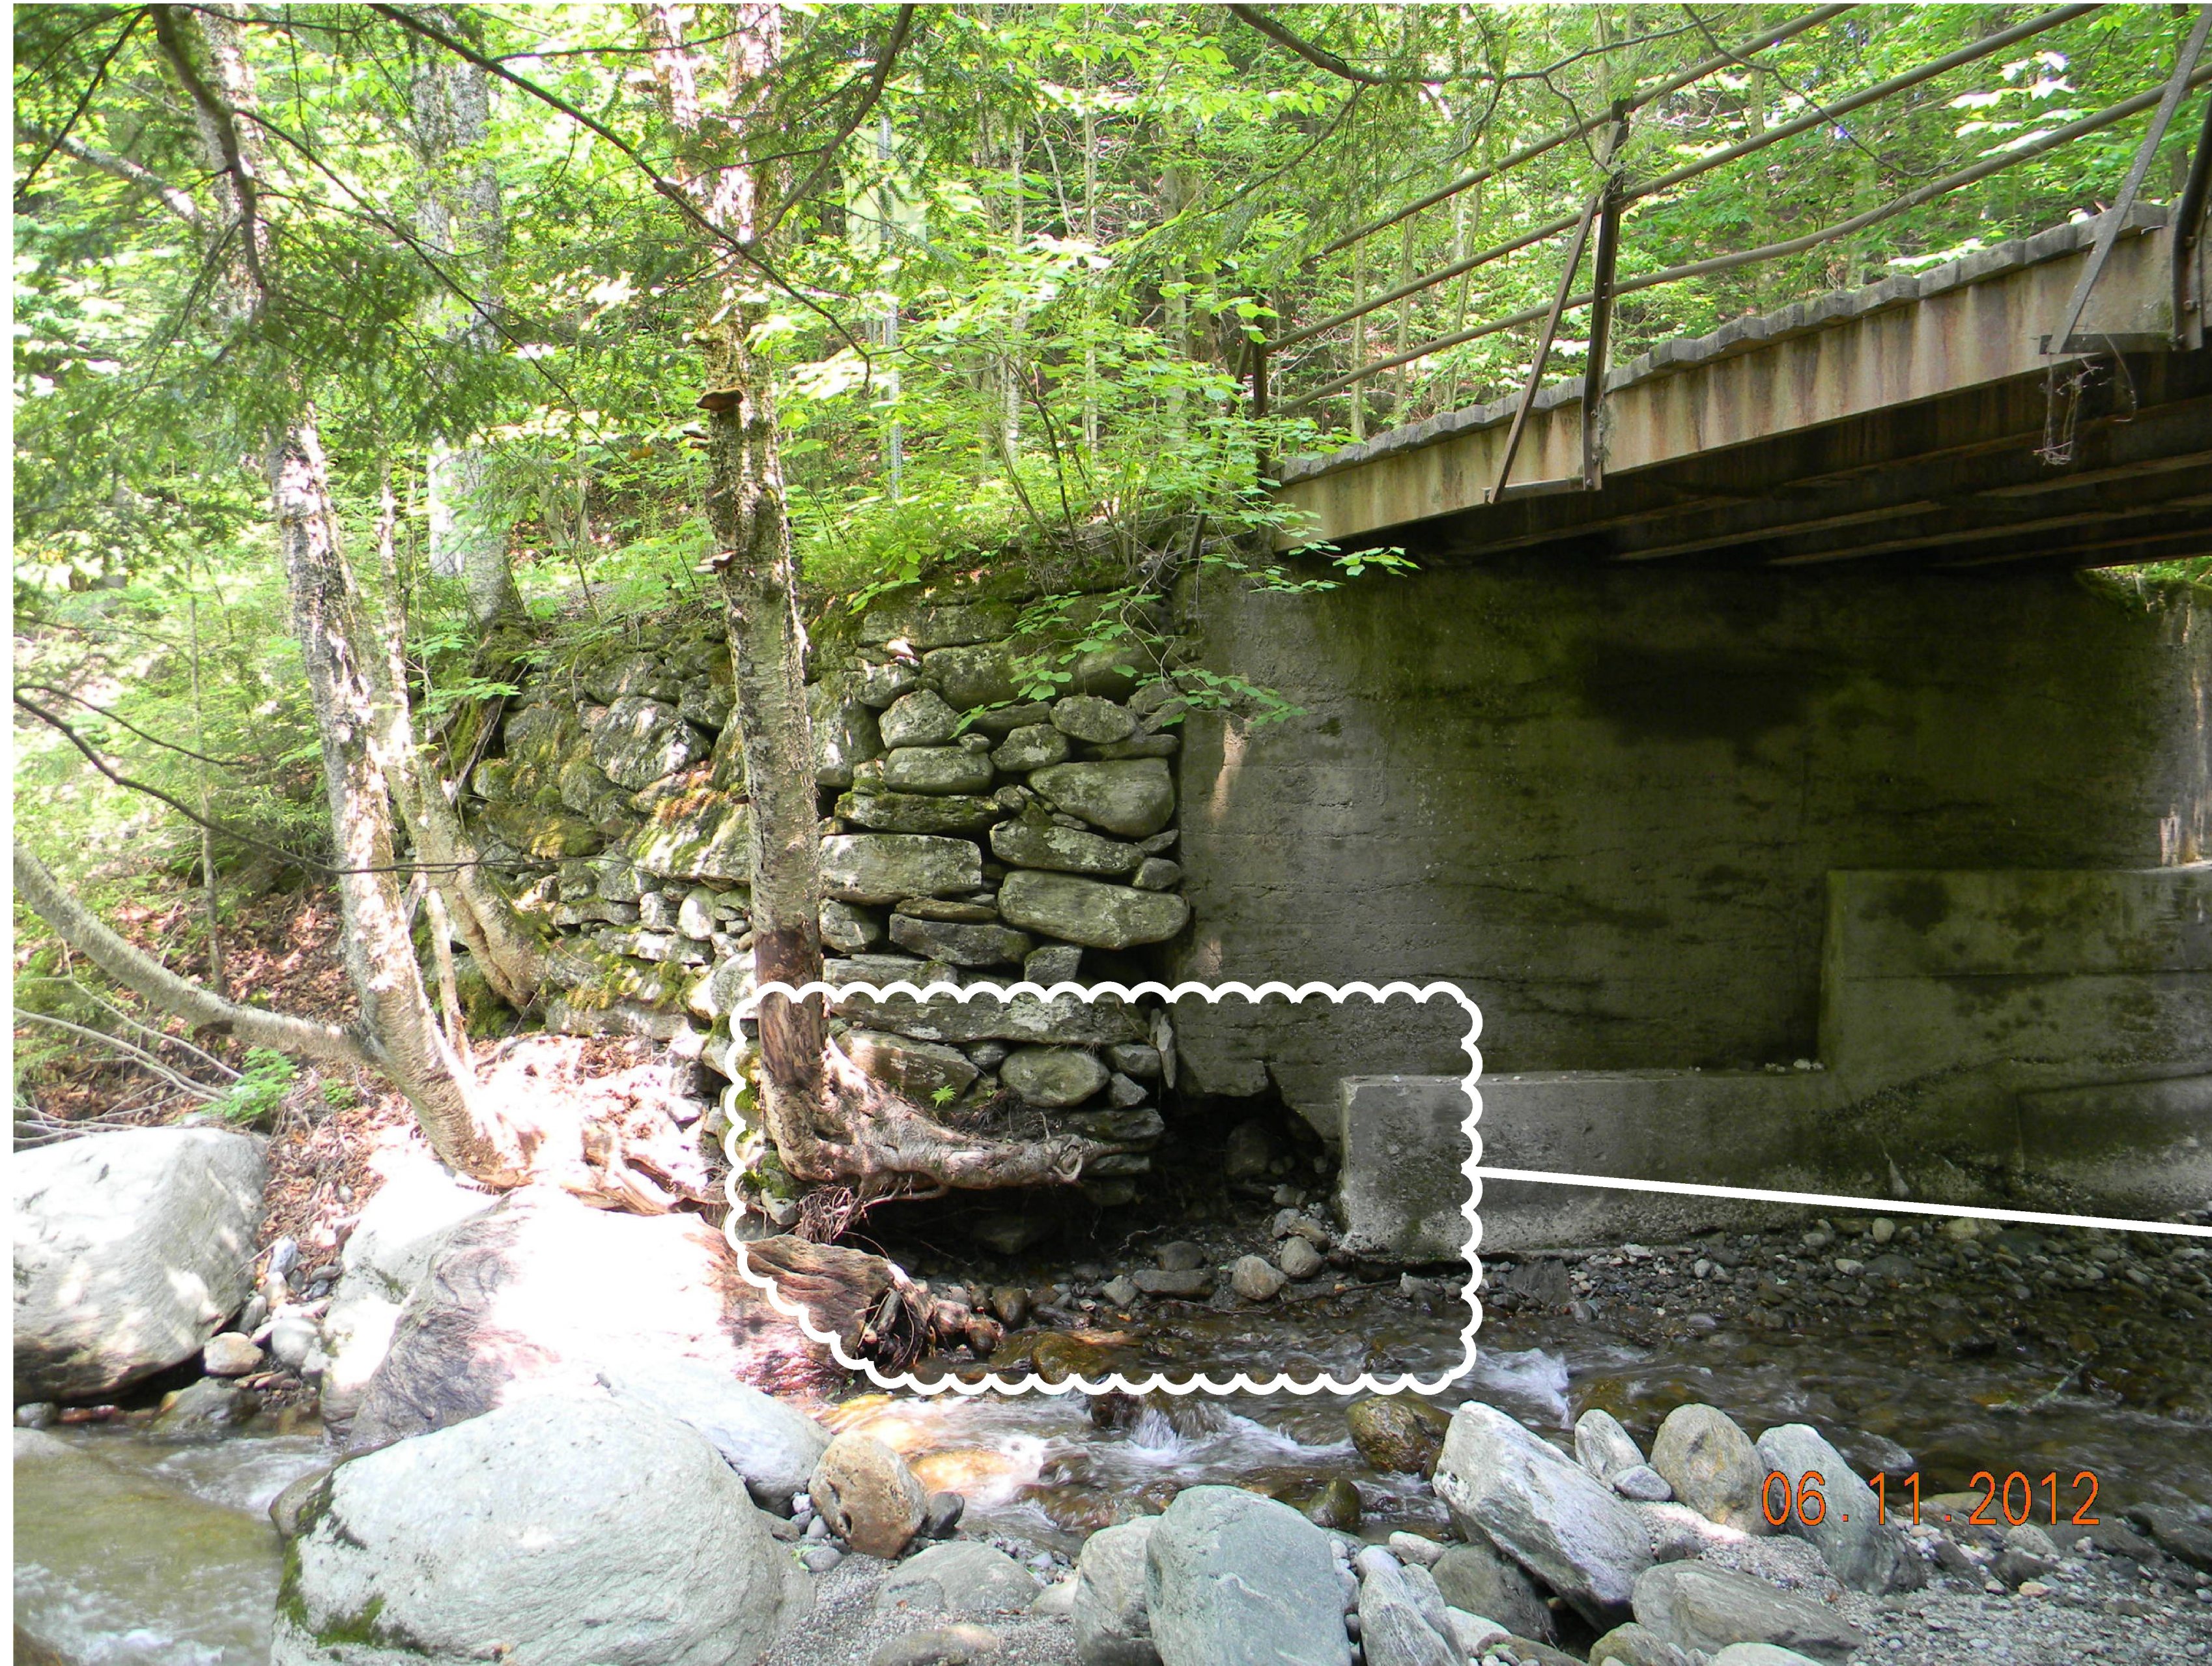
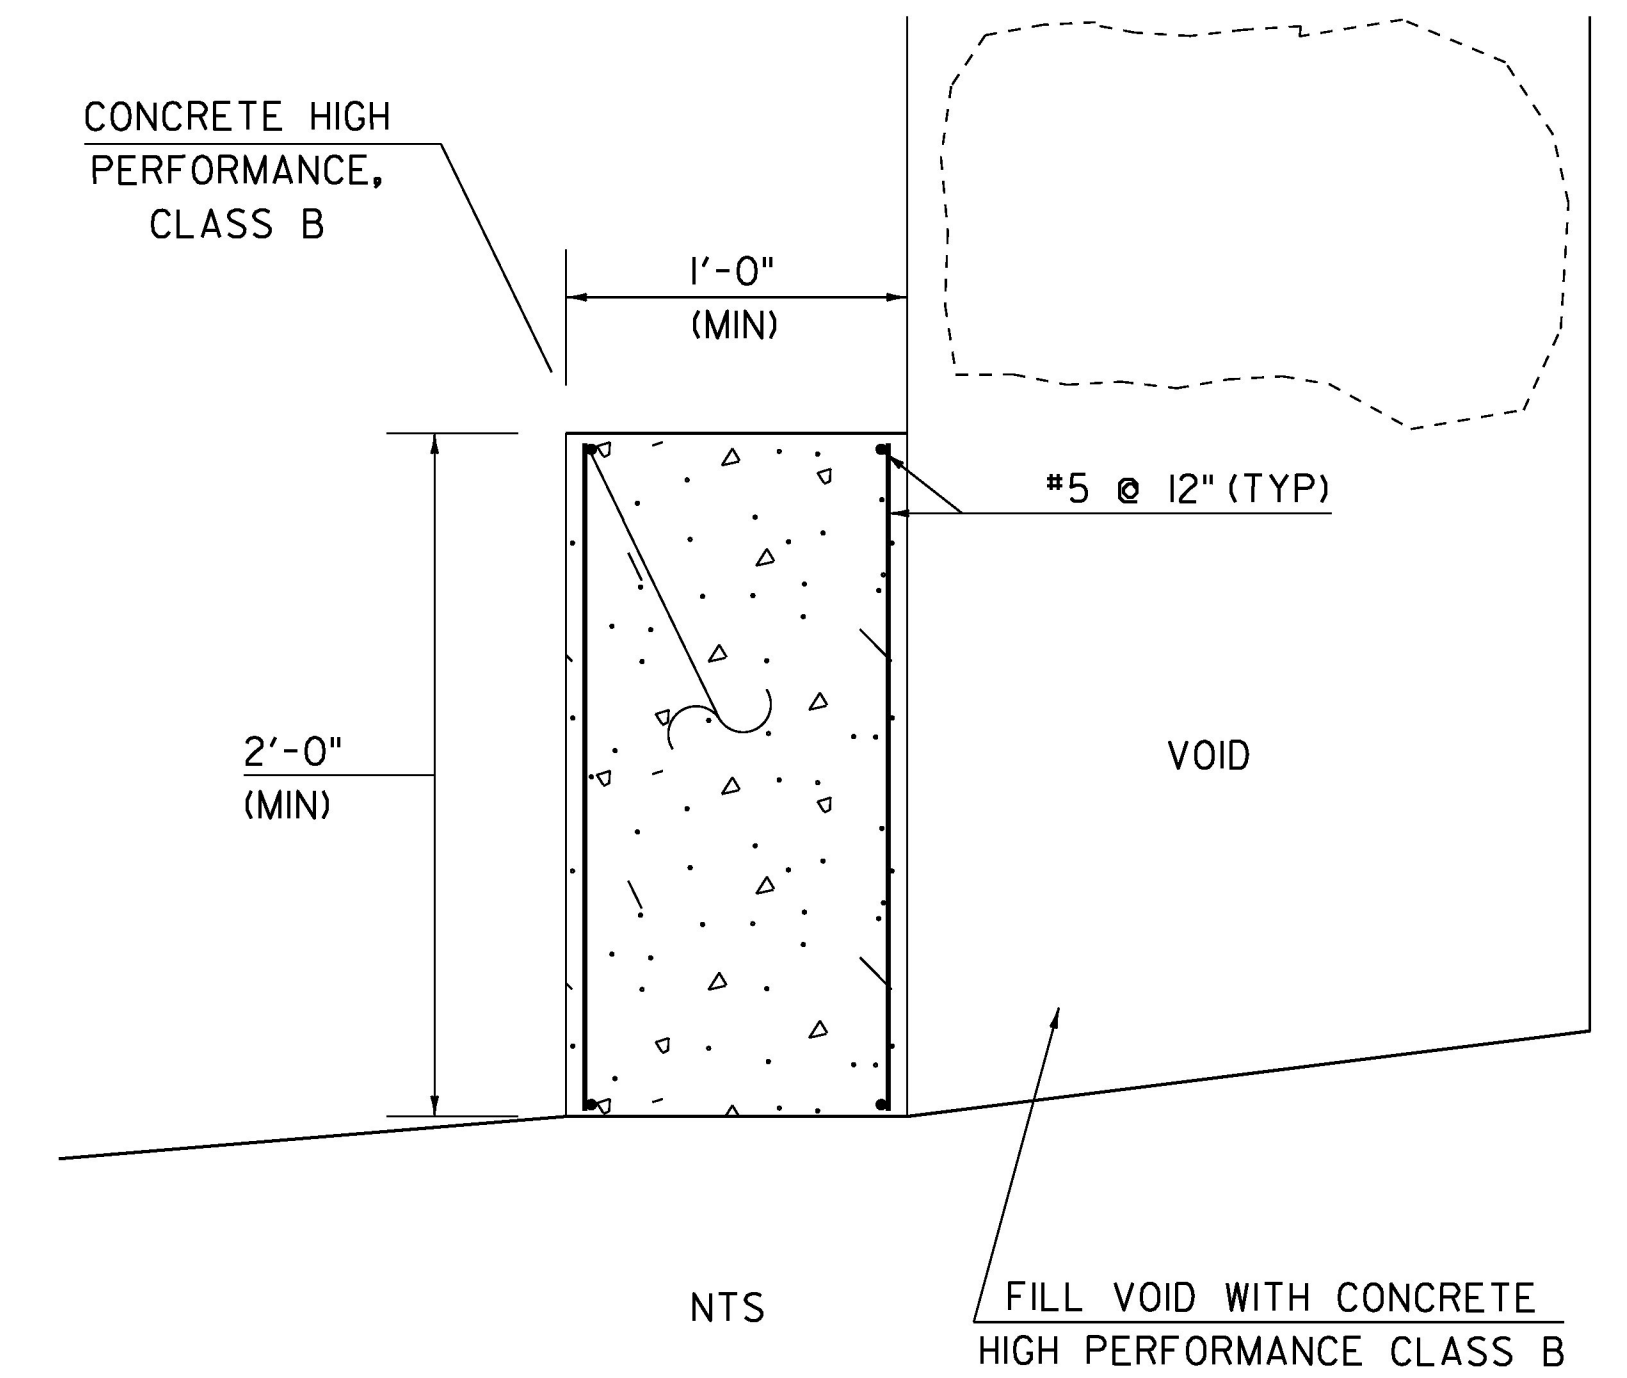
THE PICTURES REPRESENT THE EXISTING CONDITION OF THE WINGWALL #2 SUBSTRUCTURE BUT DOES NOT SHOW ALL THE AFFECTED AREAS.

THE INTENTION IS TO FILL THE VOIDS IN WINGWALL #2 WITH CONCRETE. PAYMENT FOR THIS WORK WILL BE MADE UNDER ITEM 501.34 CONCRETE, HIGH PERFORMANCE CLASS B AND ITEM 507.11 REINFORCING STEEL, LEVEL 1.

THE DEAD TREE IS TO BE REMOVED BEFORE FORMING AND POURING OF CONCRETE.

THE ENGINEER WILL DETERMINE THE LEVEL OF REPAIR NEEDED.
