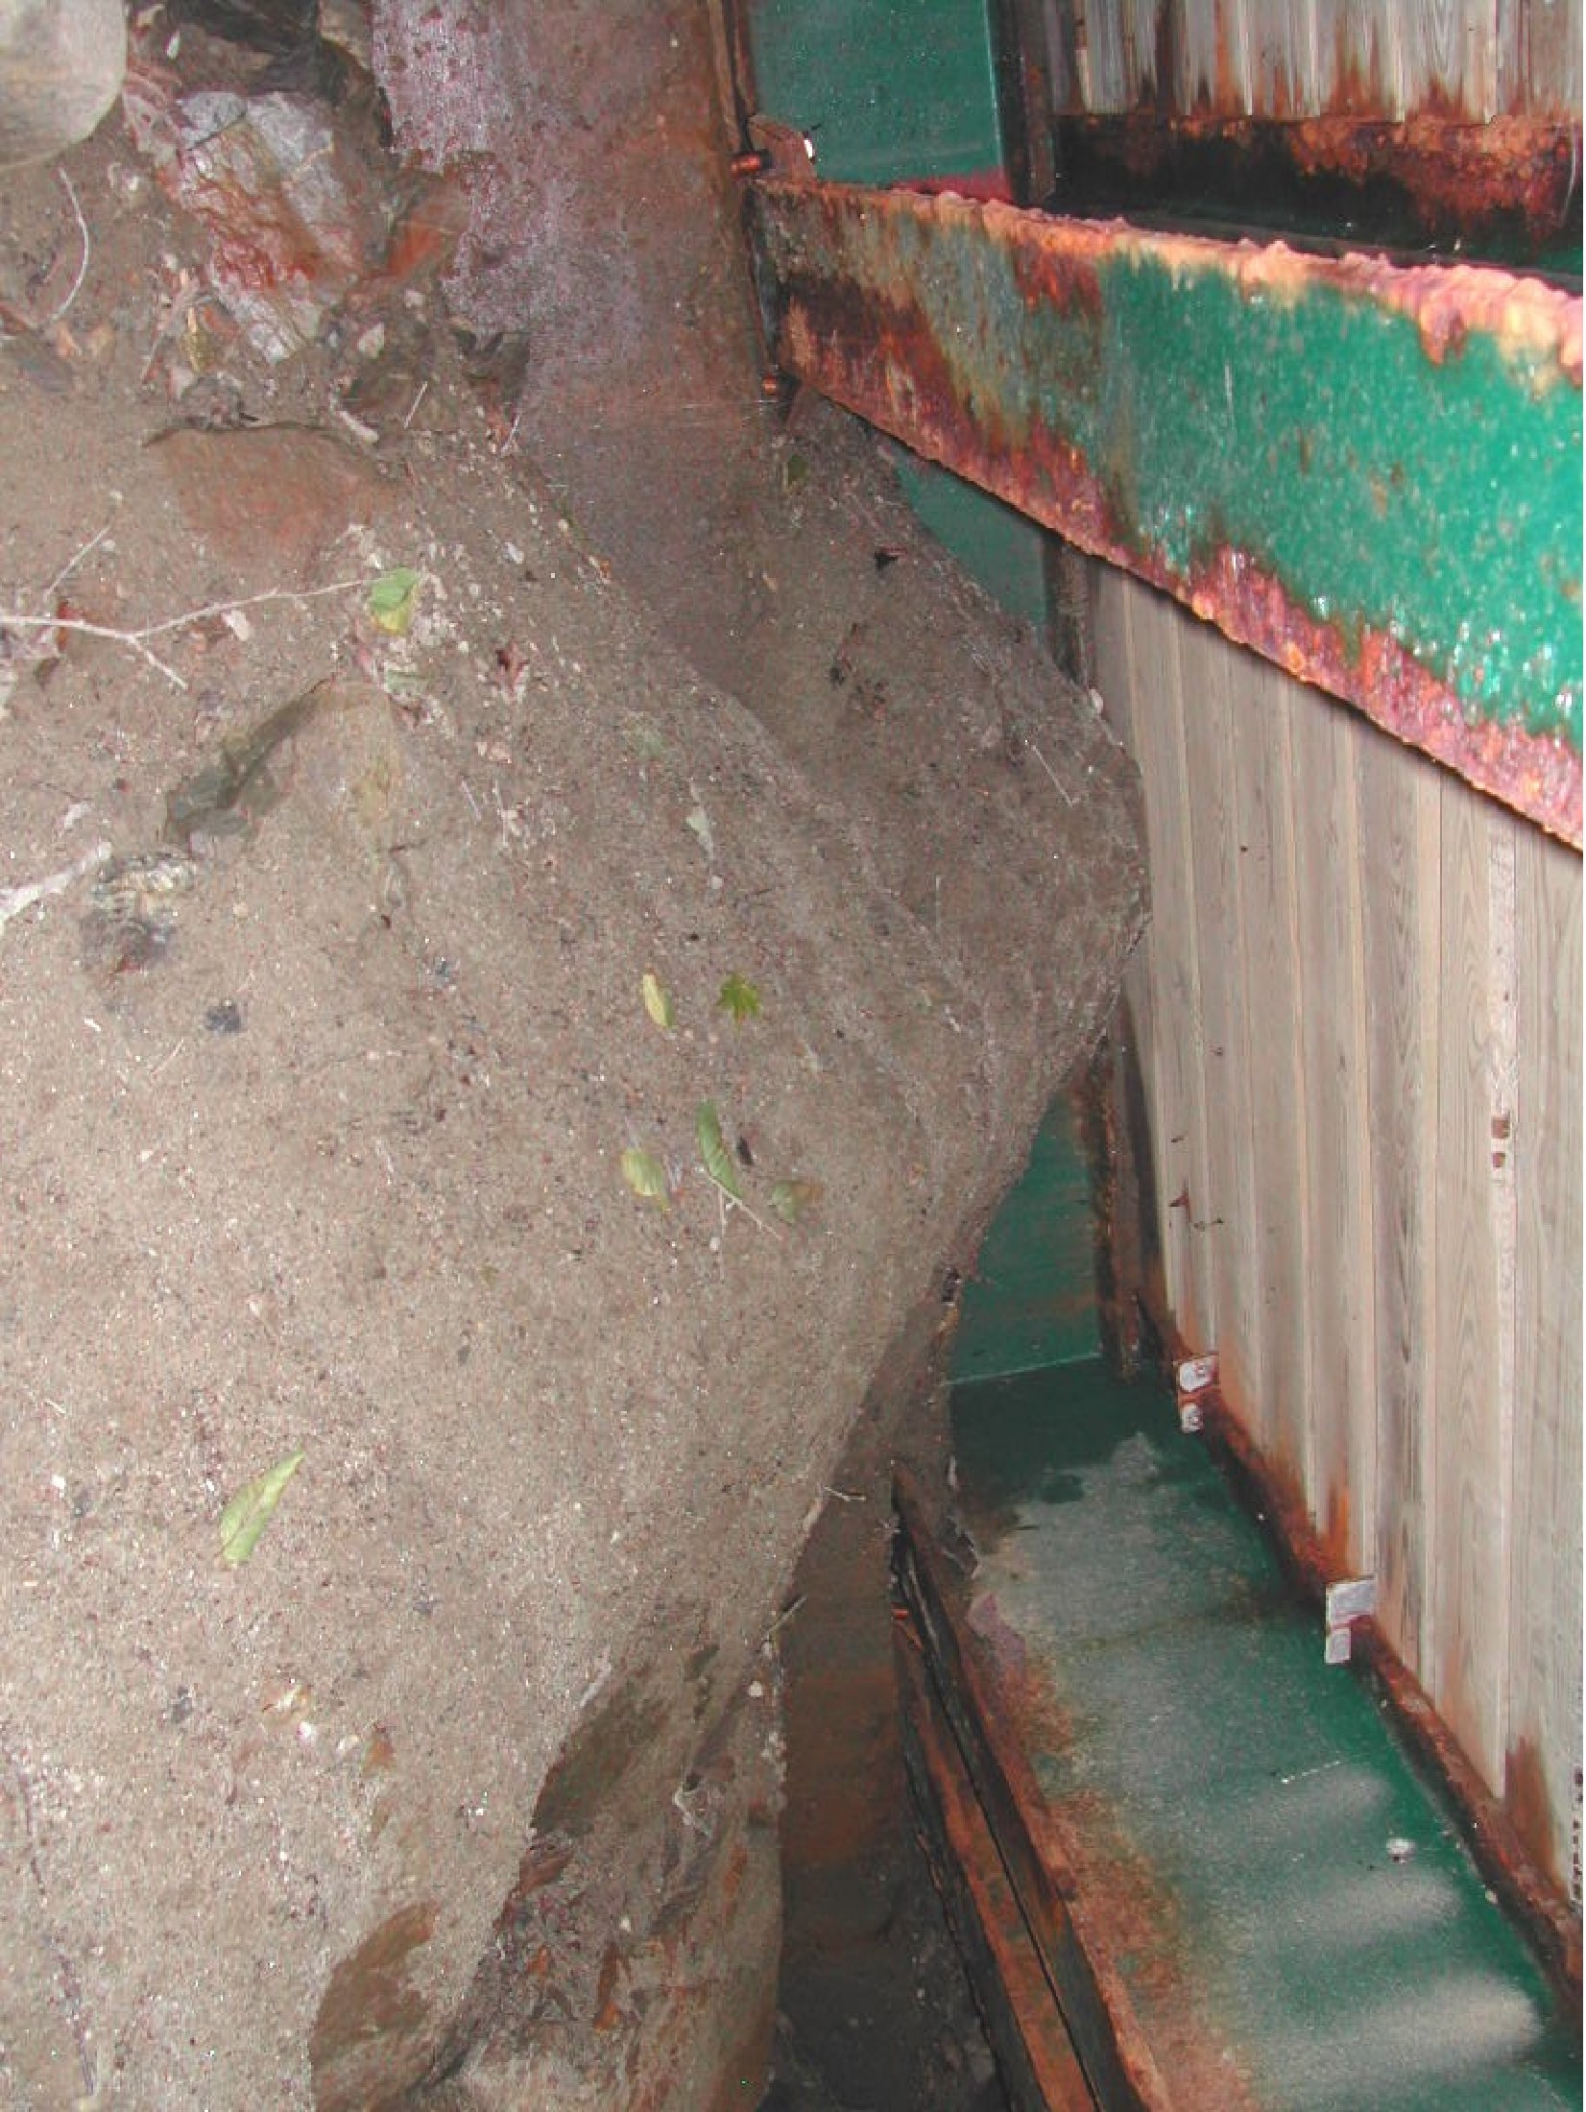
1-1/8" OF TRANSLATION IN ONE FOOT AT RIGHT END
OF ABUTMENT 1

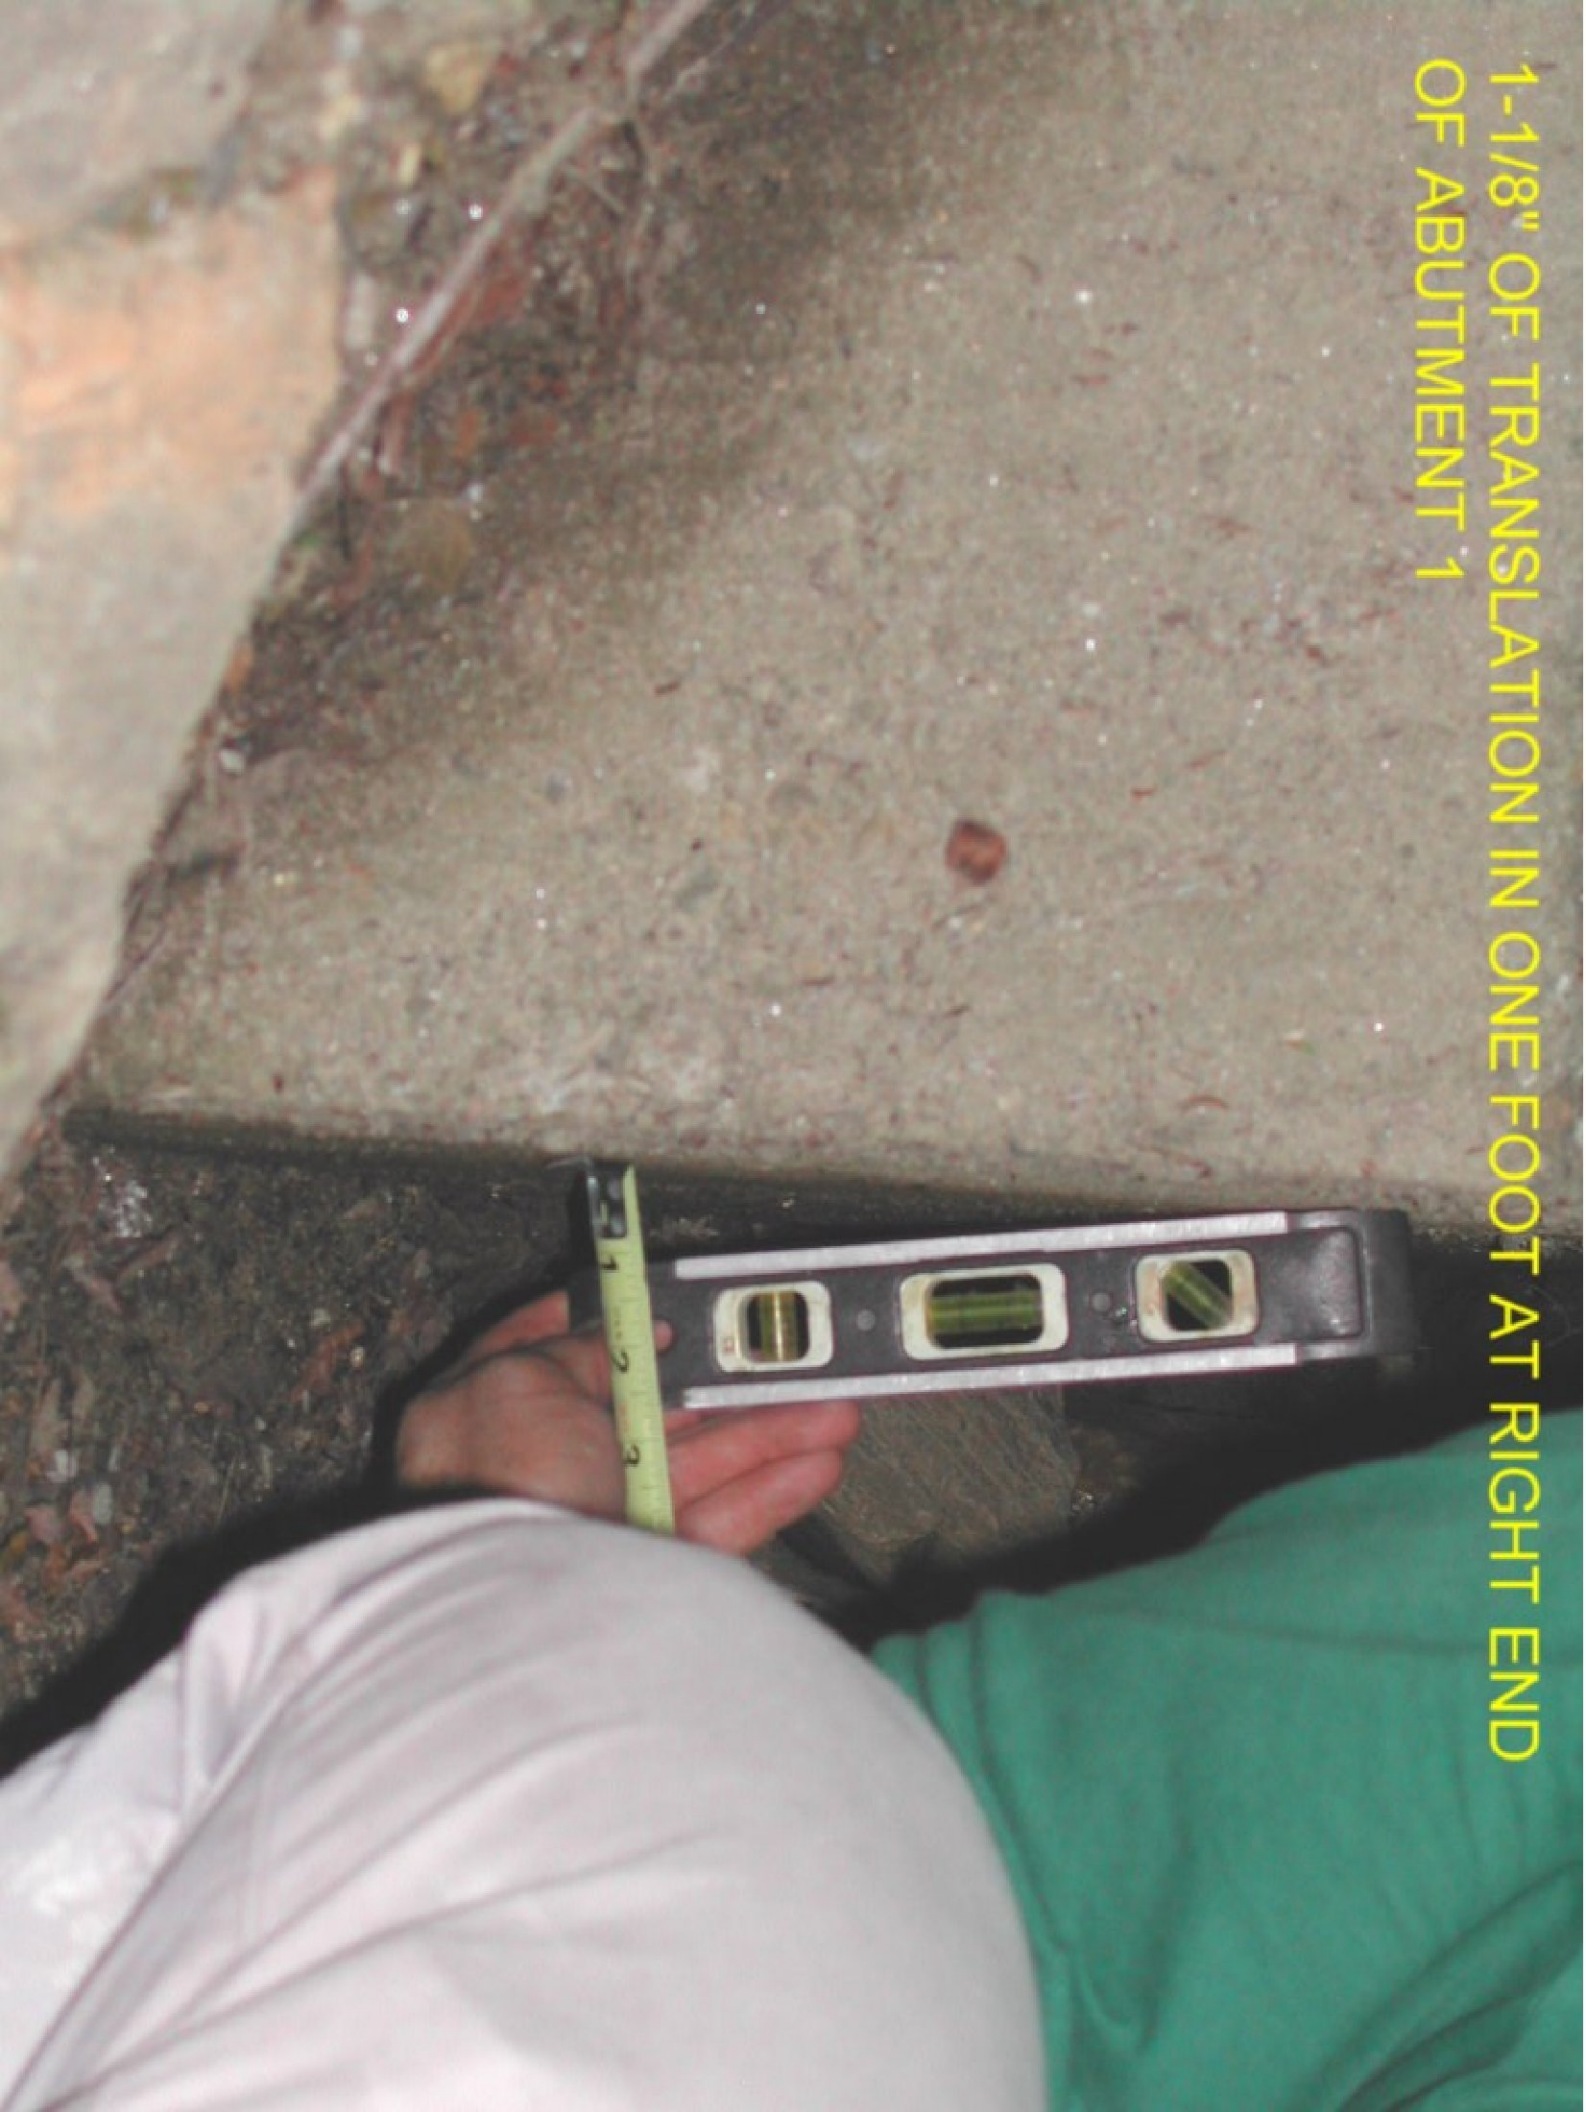
INADEQUATE BEAM SPACING ALONG CENTERLINE
DOES NOT ALLOW FOR LEGAL LOAD CARRYING
CAPACITY IF WHEEL LOAD DRIFTS OF RUNNERS
