**KITCHEN ELEVATIONS - ABOVE**

**COMMUNICATIONS ELEVATION - ABOVE**

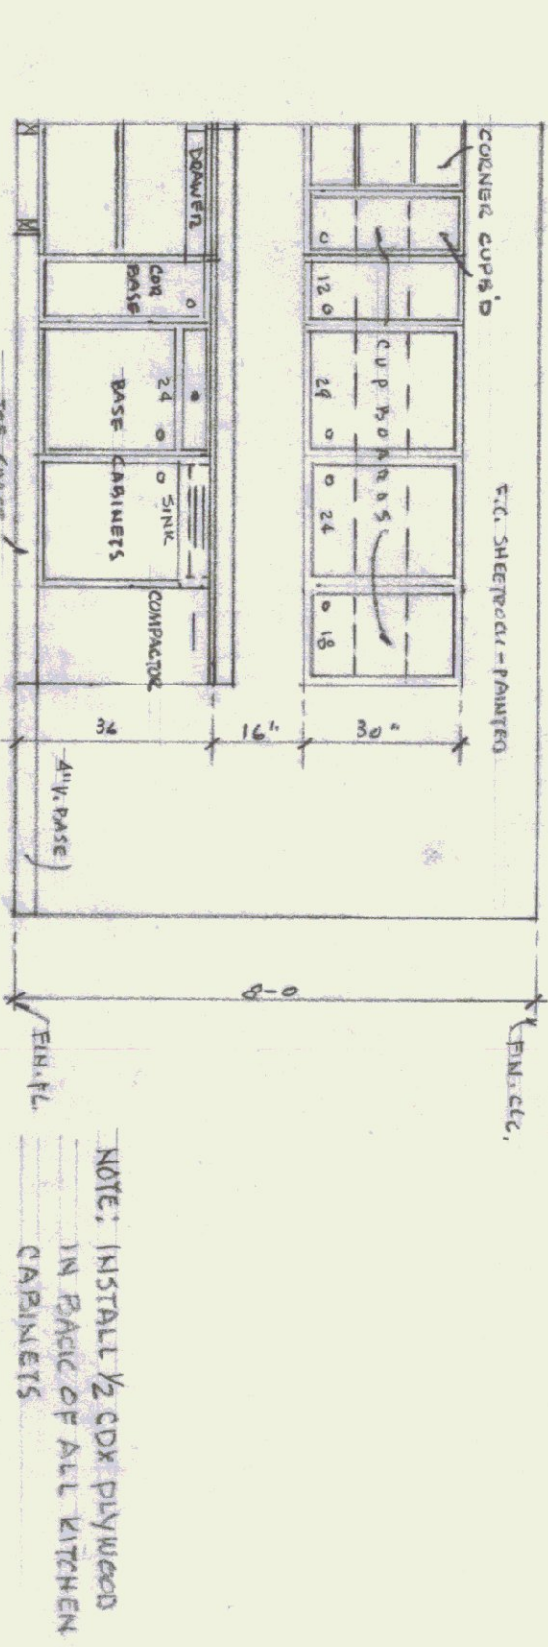
**ELEVATION OF SINK WALL**

NOTE: INSTALL 1/2 CDX PLYWOOD IN BACK OF ALL KITCHEN CABINETS

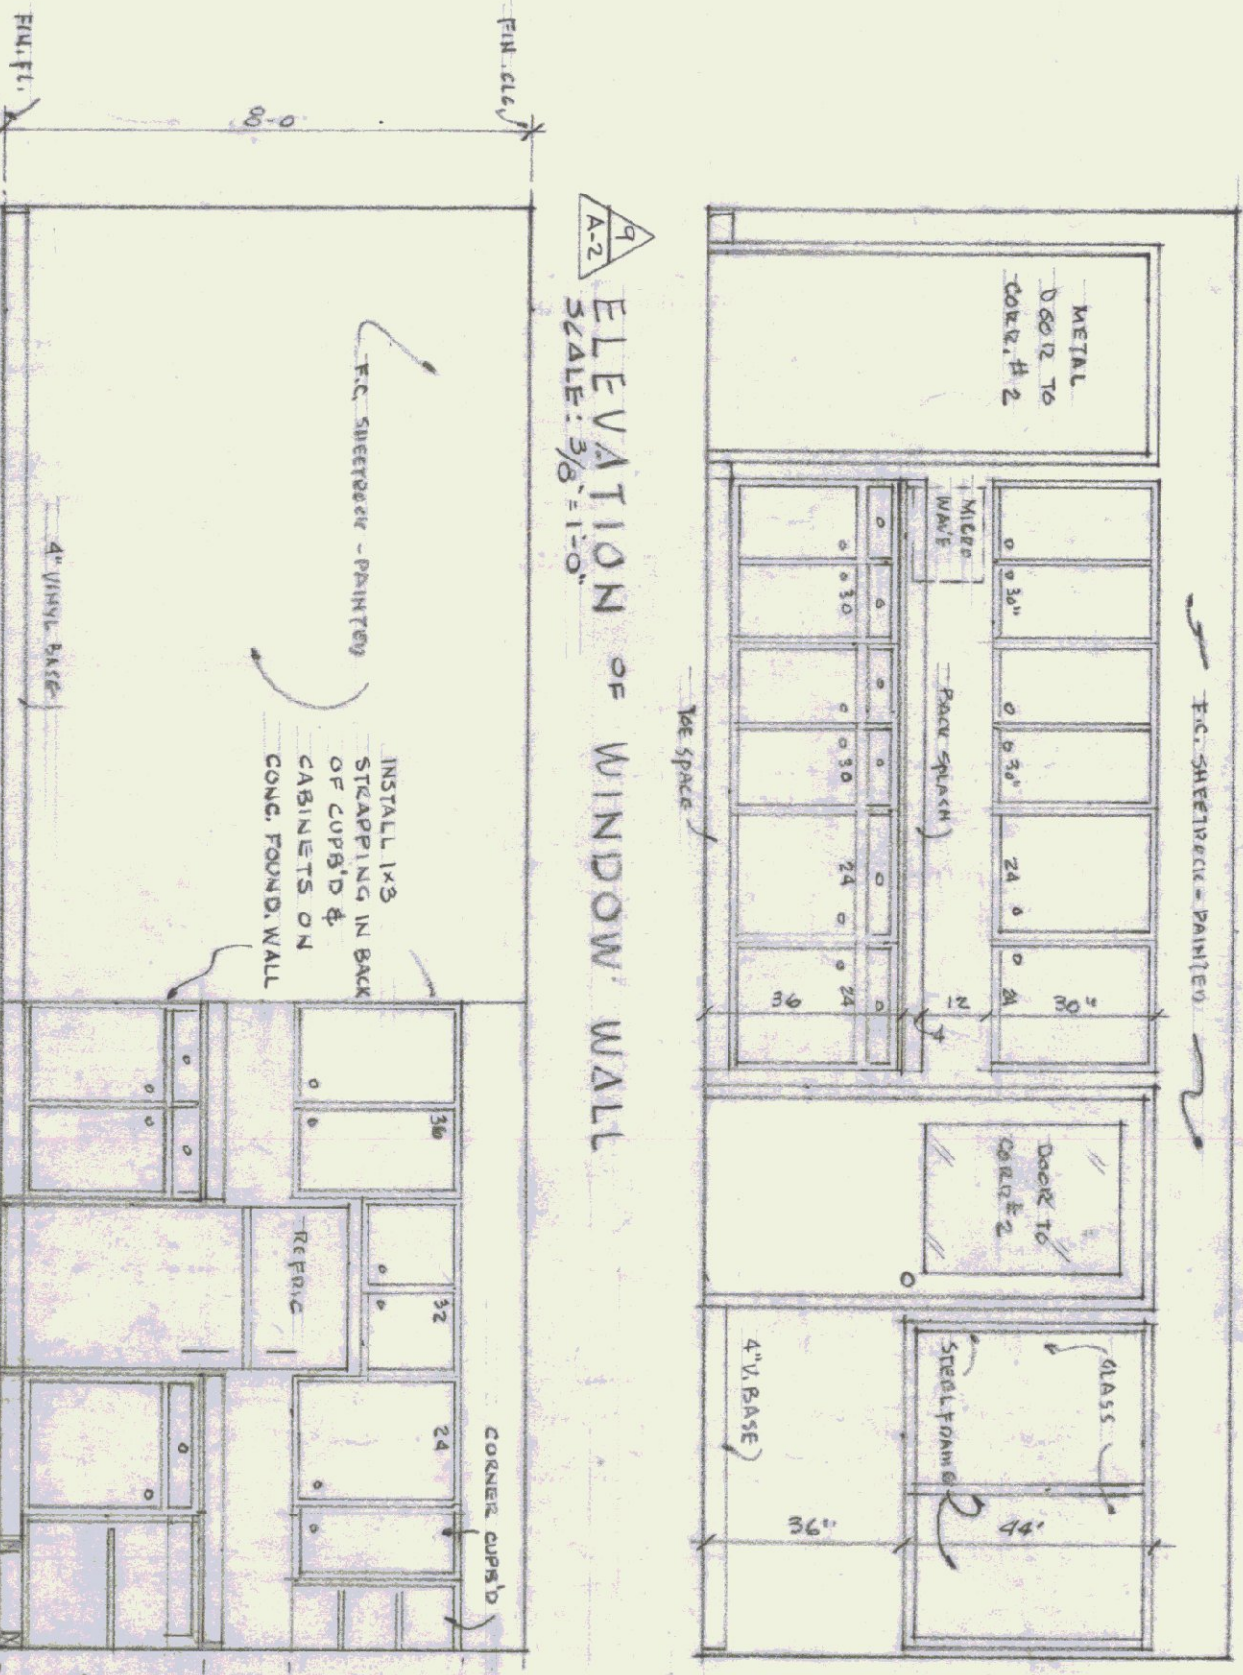
**ELEVATION OF WINDOW WALL**

**ELEVATION OF REFRIGERATOR WALL**

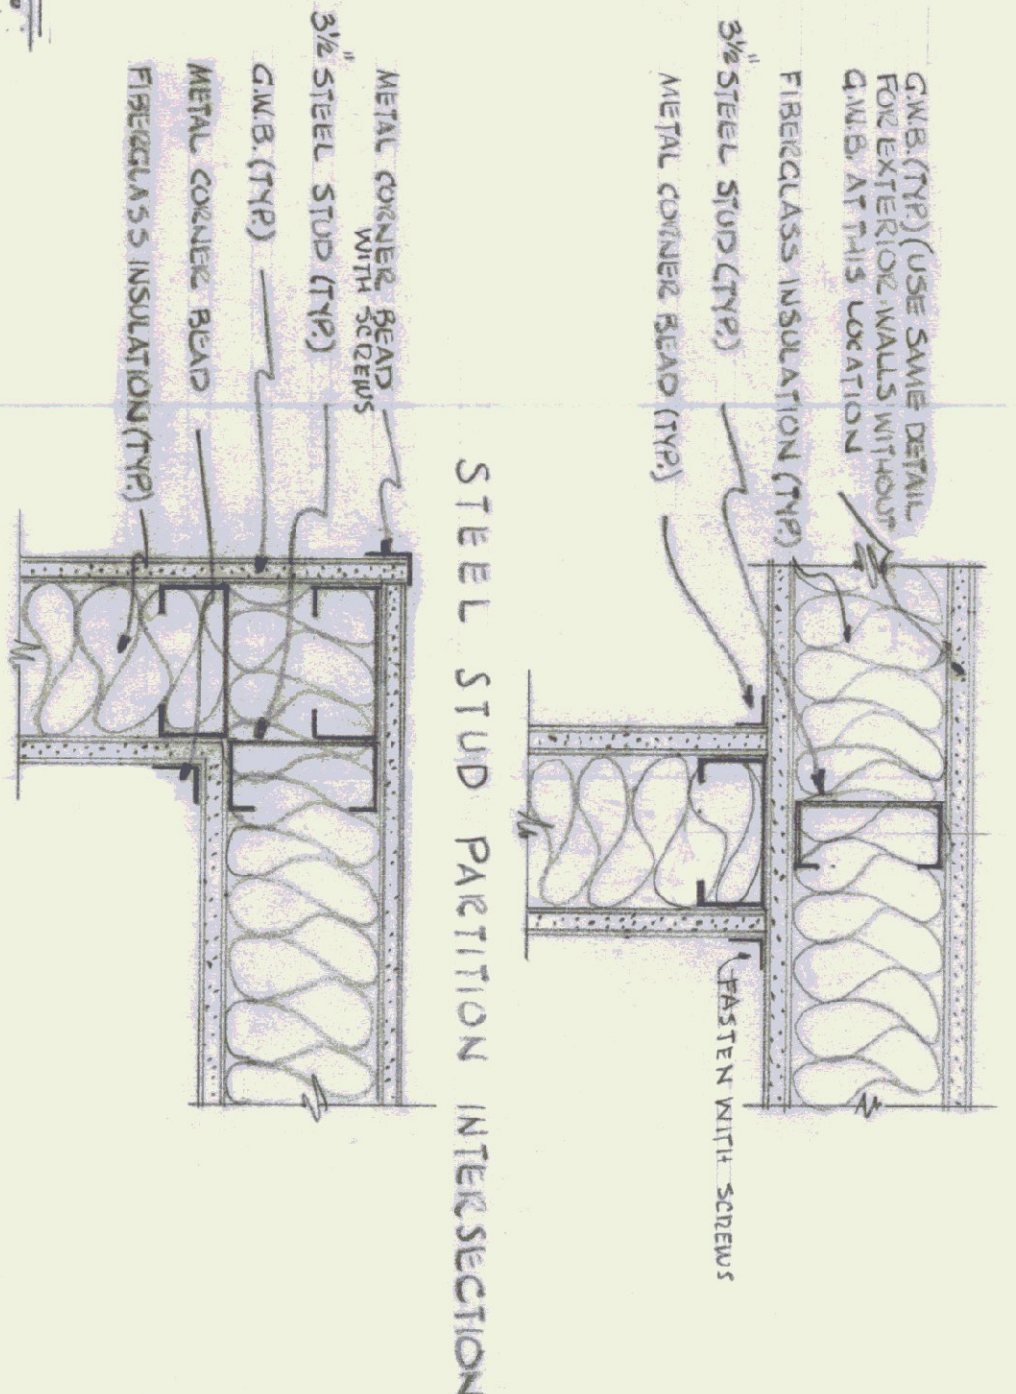
**STEEL STUD PARTITION INTERSECTION**

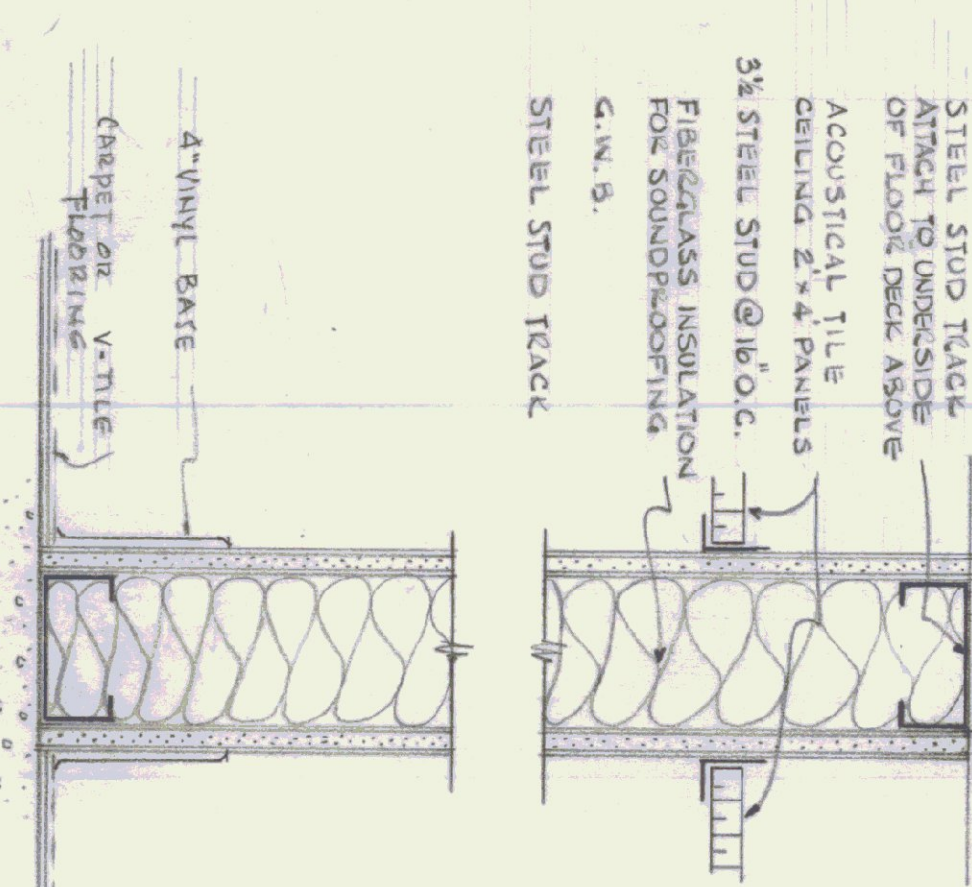
**STEEL STUD TRACK**
