**FAIRHAVEN, VERMONT**

**FAIR HAVEN WELCOME CENTER**

**WELCOME CENTER SITE PLAN**

**RECORD DRAWING**

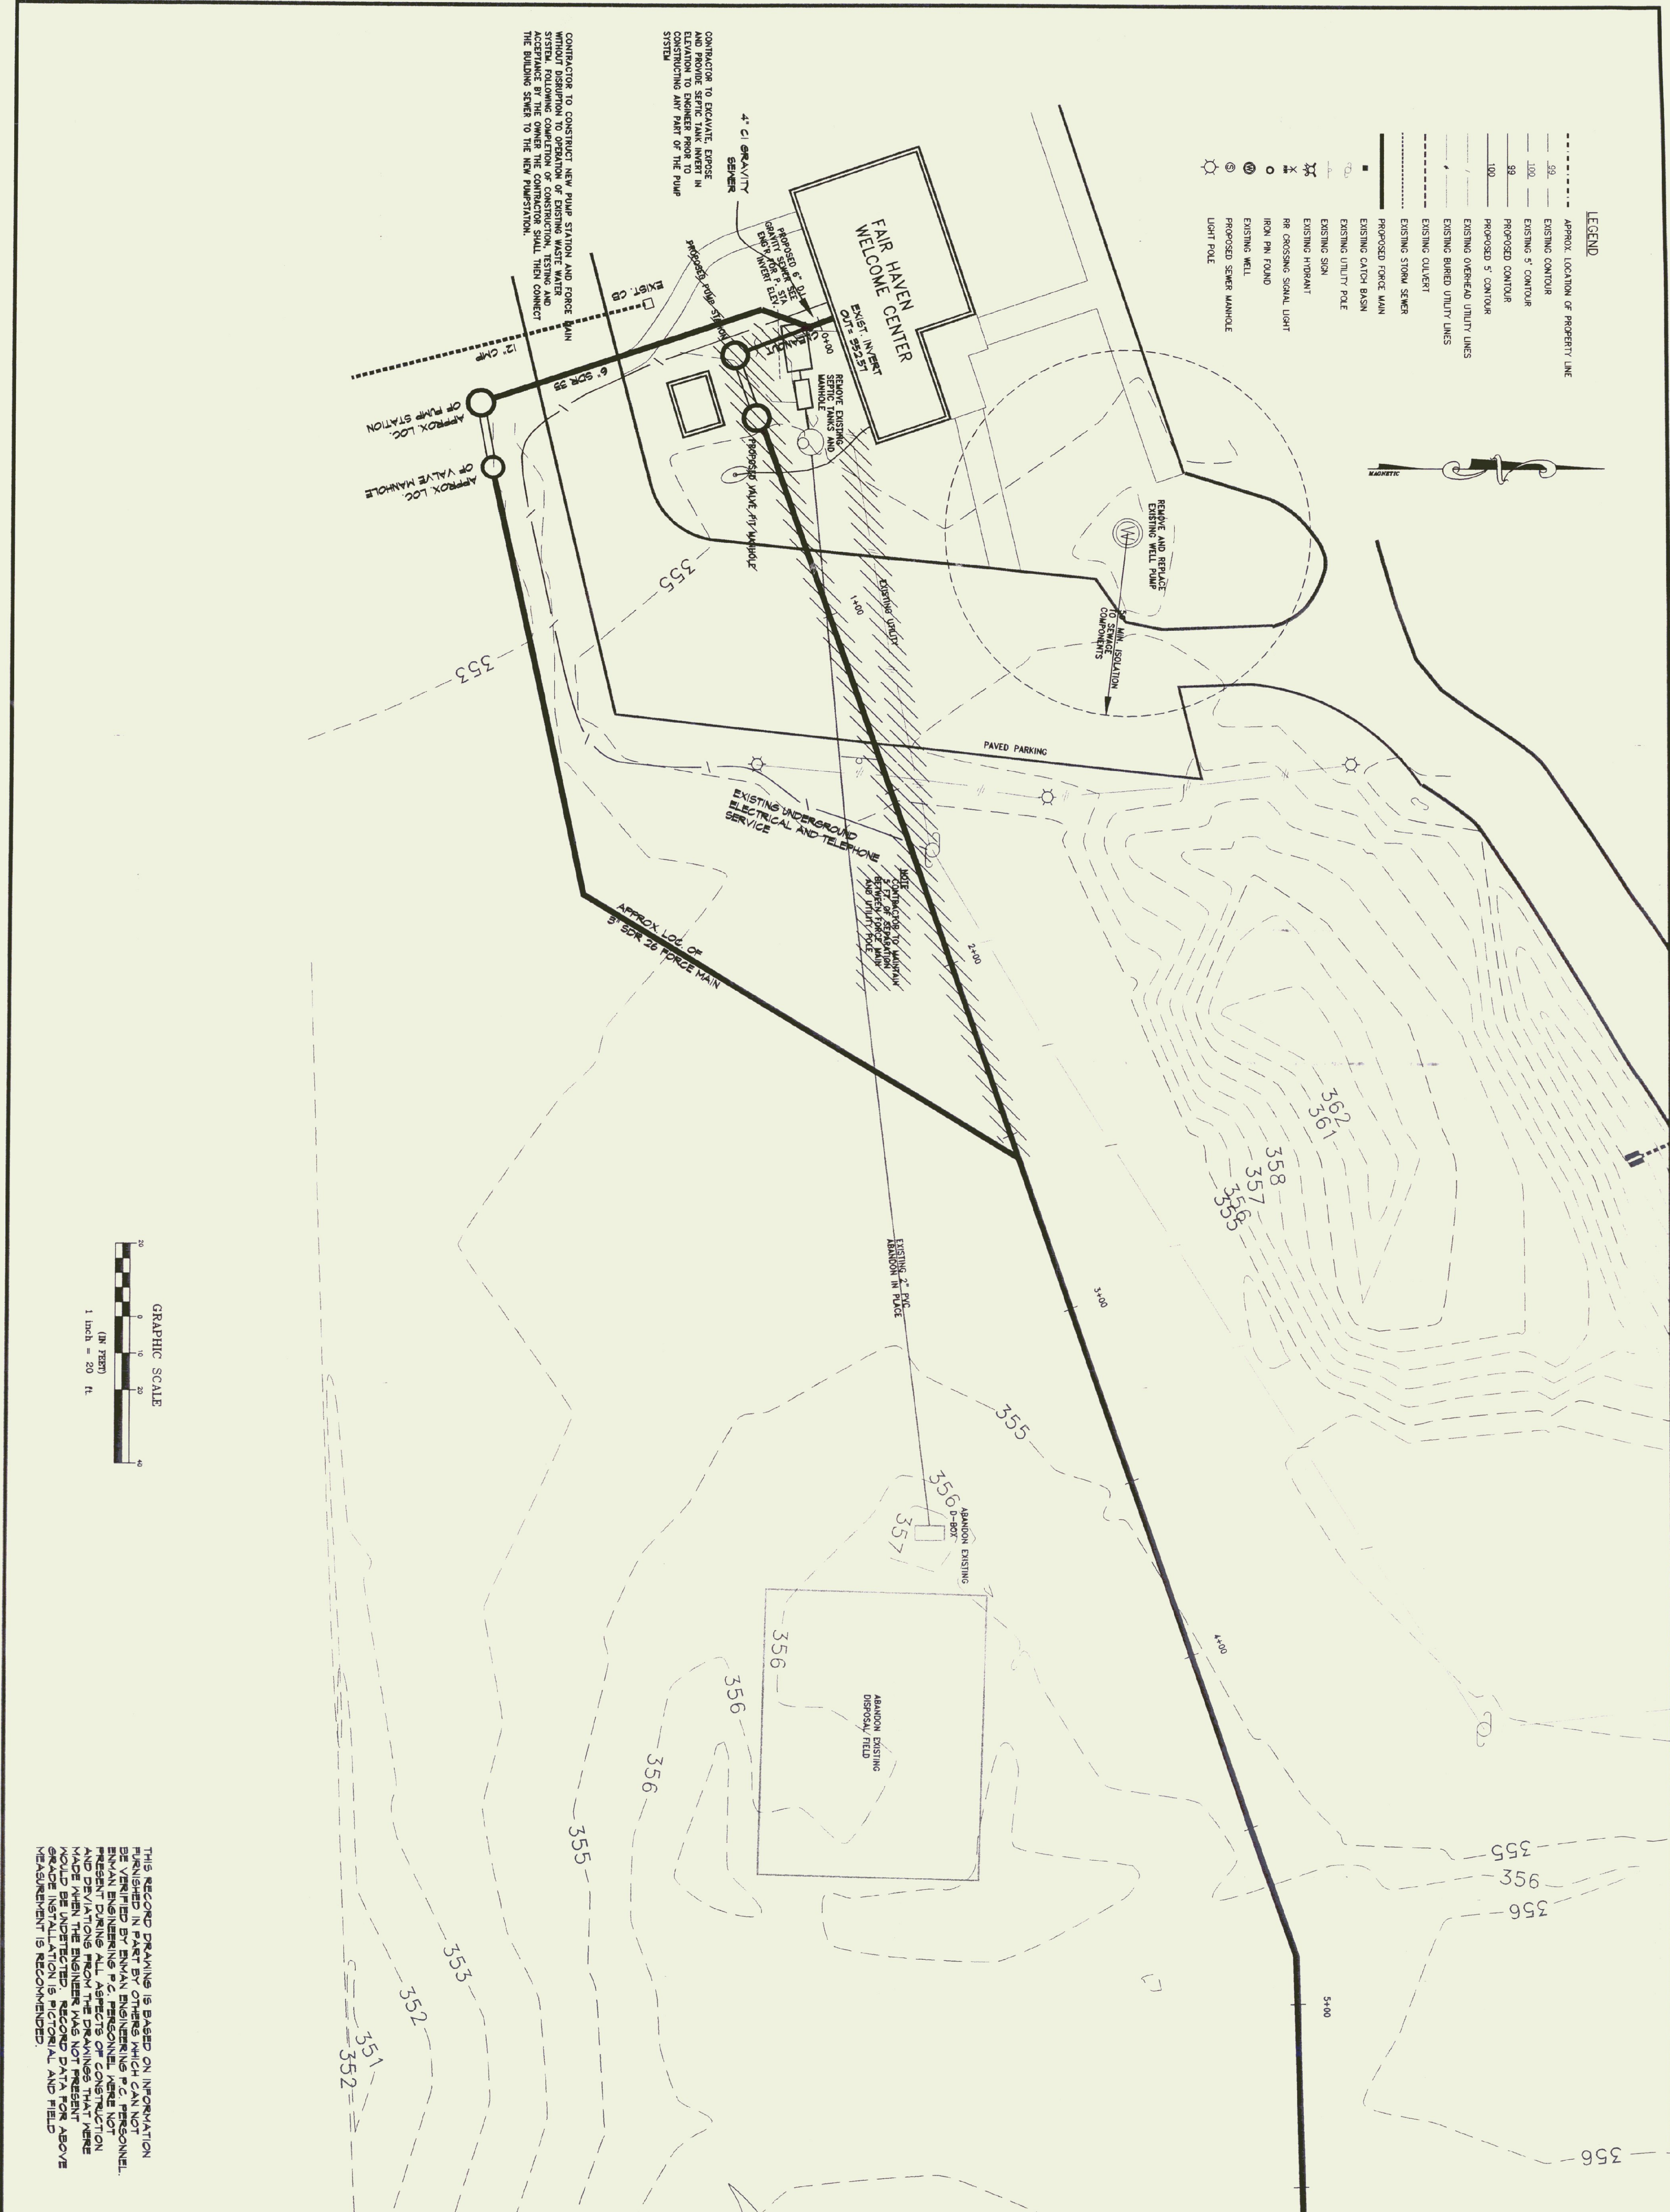
CONTRACTOR TO EXCAVATE EXPOSED AND PROVIDE SEPTIC TANK INVERT IN ELEVATION TO ENGINEER PRIOR TO CONSTRUCTING ANY PART OF THE SYSTEM

CONTRACTOR TO CONSTRUCT NEW PUMP STATION AND FORCE MAIN WITHOUT DISRUPTION TO OPERATION OF EXISTING WATER SYSTEM. FOLLOWING COMPLETION OF CONSTRUCTION, TESTING AND ACCEPTANCE BY THE OWNER THE CONTRACTOR SHALL THEN CONNECT THE BUILDING SEWER TO THE NEW PUMPSTATION.
